Device	XMC1400
Marking/Step	EES-AA, ES-AA, AA
Package	PG-VQFN-40/48/64, PG-LQFP-64, PG-TSSOP-38

Overview

This “Errata Sheet” describes product deviations with respect to the user documentation listed below.

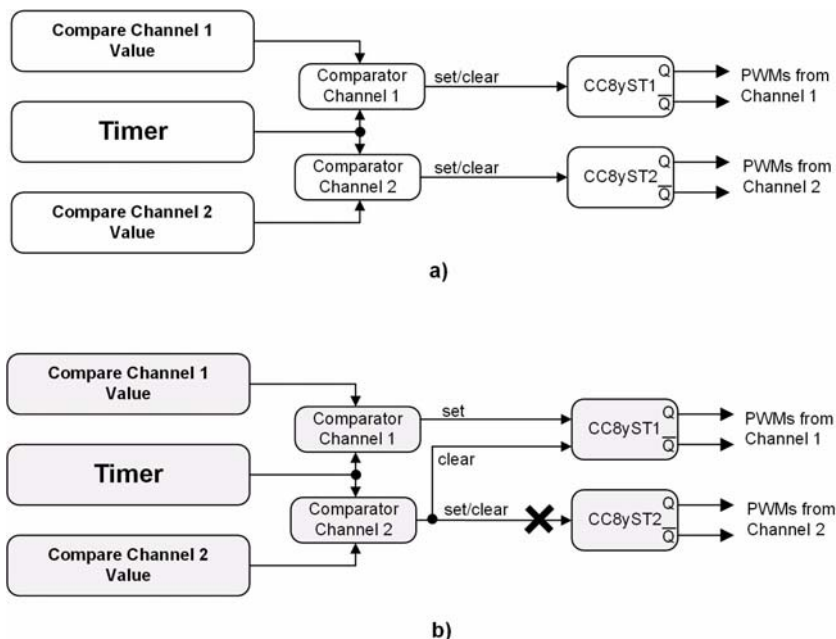
Figure 1 CCU8 simplifier PWM generation scheme - a) normal mode; b) asymmetric mode

The asymmetric mode has a bug, where the PWM signal of Compare Channel 2 is not stored in CC8yST2. This means that from the Compare Channel 2 the timer cannot generate any PWM signal - depicted by the cross on **Figure 1 b)**.

Note that the asymmetric PWM is still stored in CC8yST1 and can be used normally by the application.

None

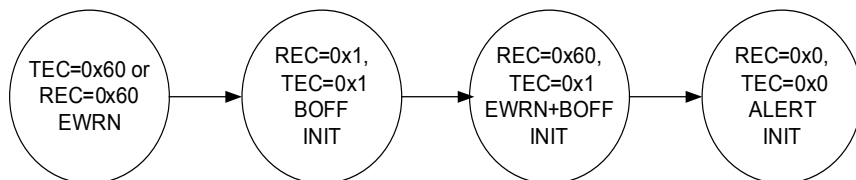
Figure 3 Alert Interrupt Behavior in case of Bus-Off

When the threshold for error warning (EWRN) is reached (default value of Error Warning Level EWRN = 0x60), then the EWRN interrupt is issued. The bus-off (BOFF) status is reached if TEC > 255 according to CAN specification, changing the MultiCAN module with REC and TEC to the same value 0x1, setting the INIT bit to 1_B, and issuing the BOFF interrupt. The bus-off recovery phase starts automatically. Every time an idle time is seen, REC is incremented. If REC = 0x60, a combined status EWRN+BOFF is reached. The corresponding interrupt can also be seen as a pre-warning interrupt, that the bus-off recovery phase will be finished soon. When the bus-off recovery phase has finished (128 times idle time have been seen on the bus), EWRN and BOFF are cleared, the ALERT interrupt bit is set and the INIT bit is still set.

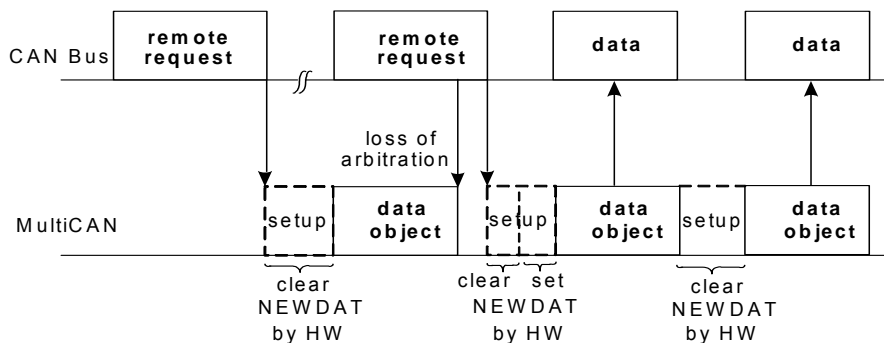
Figure 4 Loss of Arbitration

When the appropriate message object (data frame) triggered by the first remote frame wins the arbitration, it will be sent out and NEWDAT is not reset. This leads to an additional data frame, that will be sent by this message object (clearing NEWDAT).

There will, however, not be more data frames than there are corresponding remote requests.
