Device	XMC1100
Marking/Step	EES-AB, ES-AB, AB
Package	PG-TSSOP-16/38, PG-VQFN-24/40

Overview

This “Errata Sheet” describes product deviations with respect to the user documentation listed below.

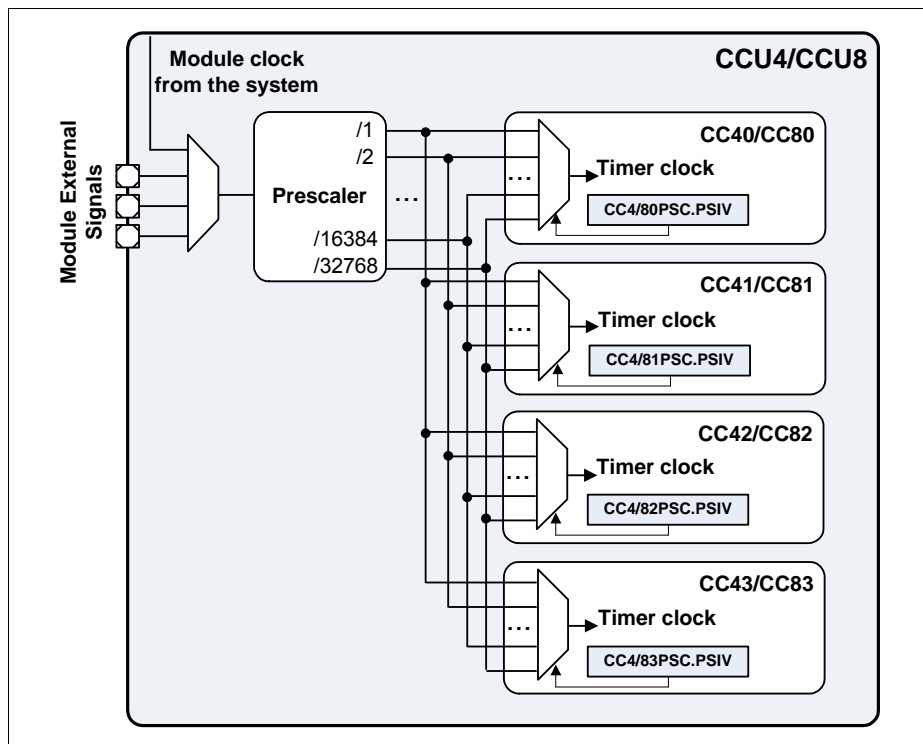
Figure 1 Clock Selection Diagram for CCU4/CCU8

Currently is only possible to use an external signal as Timer Clock when a division ratio of 2 or higher is selected. When no division is selected (divided by 1), the external signal cannot be used.

The user must program the PSIV field of each Timer Slice with a value different from 0000_B - minimum division value is /2.

None.
