Device	XMC1300
Marking/Step	EES-AB, ES-AB, AB
Package	PG-TSSOP-16/28/38, PG-VQFN-24/40

Overview

This “Errata Sheet” describes product deviations with respect to the user documentation listed below.

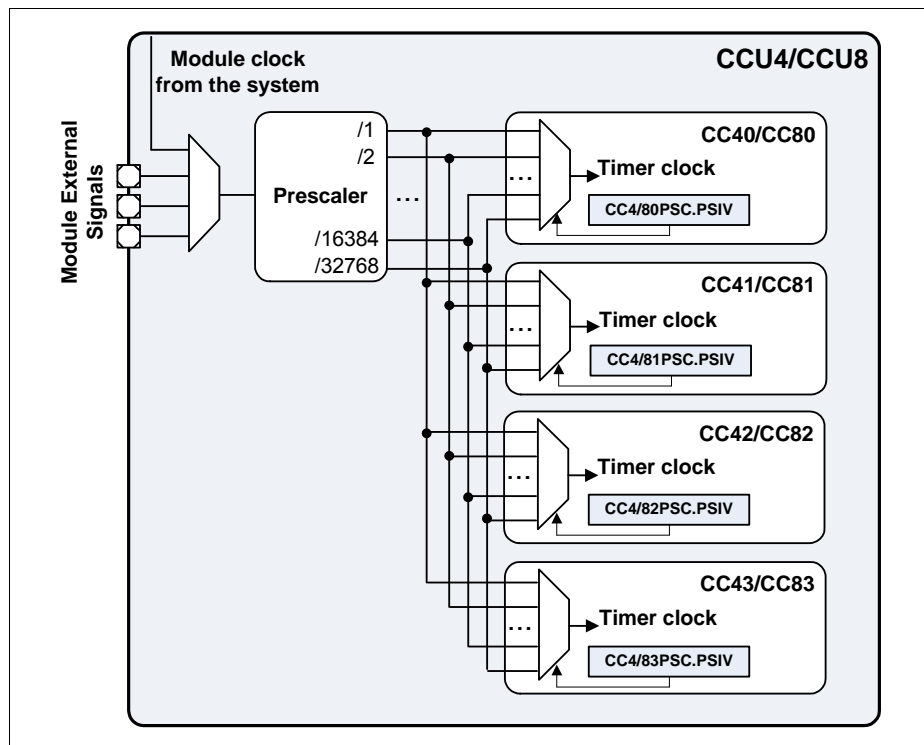
Figure 1 Clock Selection Diagram for CCU4/CCU8

Each CCU4/CCU8 module offers the possibility of selecting an external signal to be used as the master clock for every timer inside the module Figure 1. External signal in this context is understood as a signal connected to other module/IP or connected to the device ports.

Currently is only possible to use an external signal as Timer Clock when a division ratio of 2 or higher is selected. When no division is selected (divided by 1), the external signal cannot be used.

The user must program the PSIV field of each Timer Slice with a value different from 0000_B - minimum division value is /2.

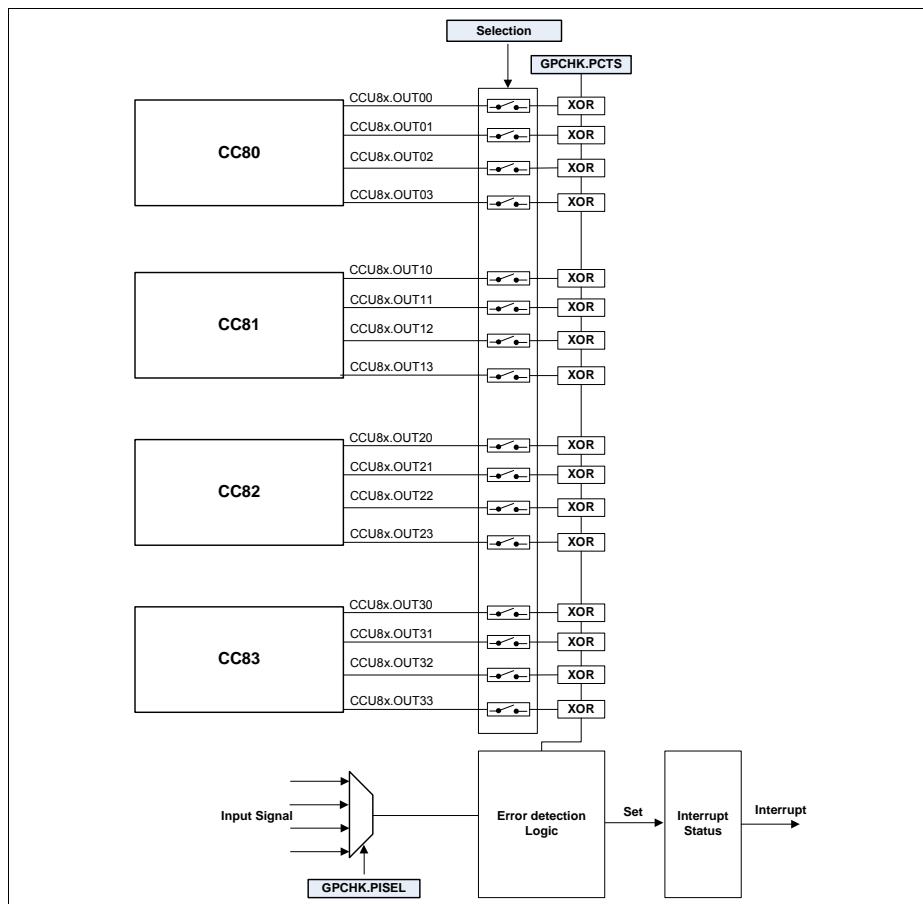
Figure 2 Parity Checker diagram

Each CCU8 module also contains a function called Parity Checker. This Parity Checker function, crosschecks the output of a XOR structure versus an input signal, as seen in Figure 1.

When using the parity checker function, the associated status bitfield, is cleared automatically by hardware in the next PWM cycle whenever an error is not present.

This means that if in the previous PWM cycle an error was detected and one interrupt was triggered, the software needs to read back the status register before the end of the immediately next PWM cycle.

Not ORing the Parity Checker error interrupt with any other interrupt source. With this approach, the software does not need to read back the status information to understand what was the origin of the interrupt - because there is only one source.

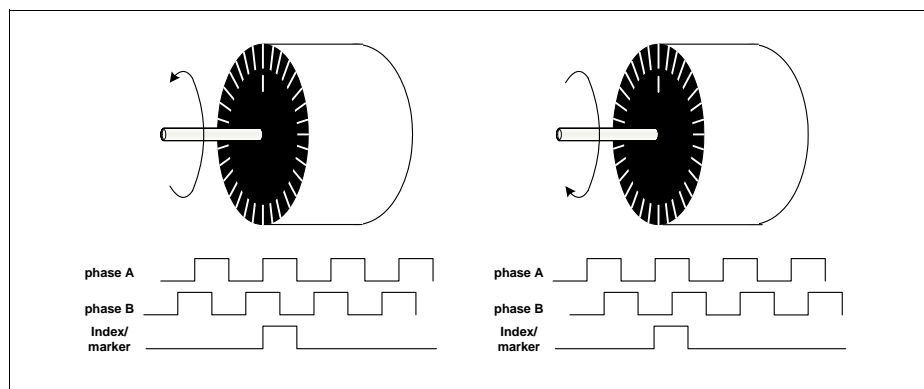
Figure 4 Rotary Encoder outputs - Phase A, Phase B and Index

Each POSIF module can be used as an input interface for a Rotary Encoder. It is possible to configure the POSIF module to decode 3 different signals: Phase A, Phase B (these two signals are 90° out of phase) and Index. The index signal is normally understood as the marker for the zero position of the motor Figure 1.

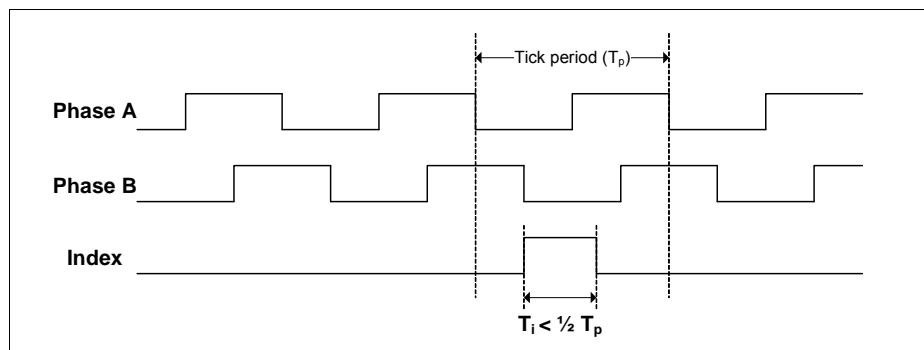
Figure 5 Different index signal types

When the index signal is smaller than 1/2 of the tick period, the POSIF module is not able to decode this signal properly, Figure 2 - notice that the reference edge of the index generation in this figure is the falling of Phase B, nevertheless this is an example and depending on the encoder type, this edge may be one of the other three.

Due to this fact it is not possible to use the POSIF to decode these type of signals (index with duration below 1/2 of the tick period).
